**FINAL ENVIRONMENTAL ASSESSMENT**

**STREAMBANK STABILIZATION  
MANASQUAN RIVER AT BERGERVILLE ROAD  
HOWELL TOWNSHIP  
MONMOUTH COUNTY, NEW JERSEY**

**November 2006**

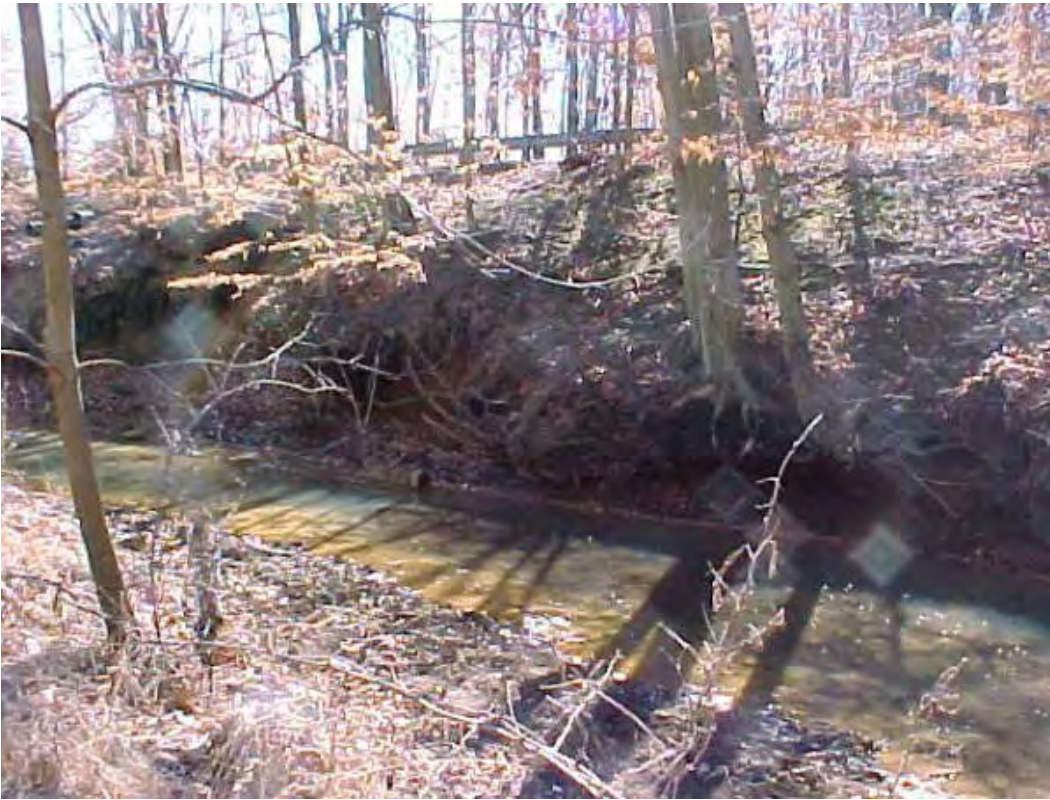
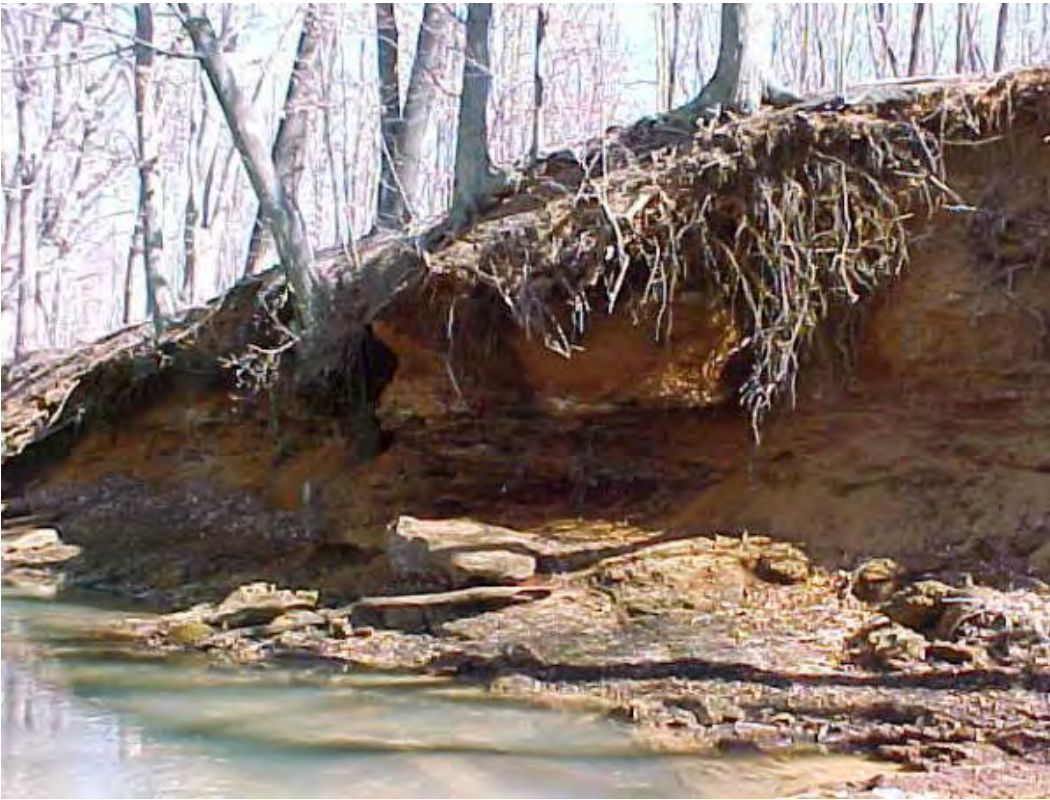
Figure 1-2. Photographs of Manasquan River Stream Bank Stabilization project location

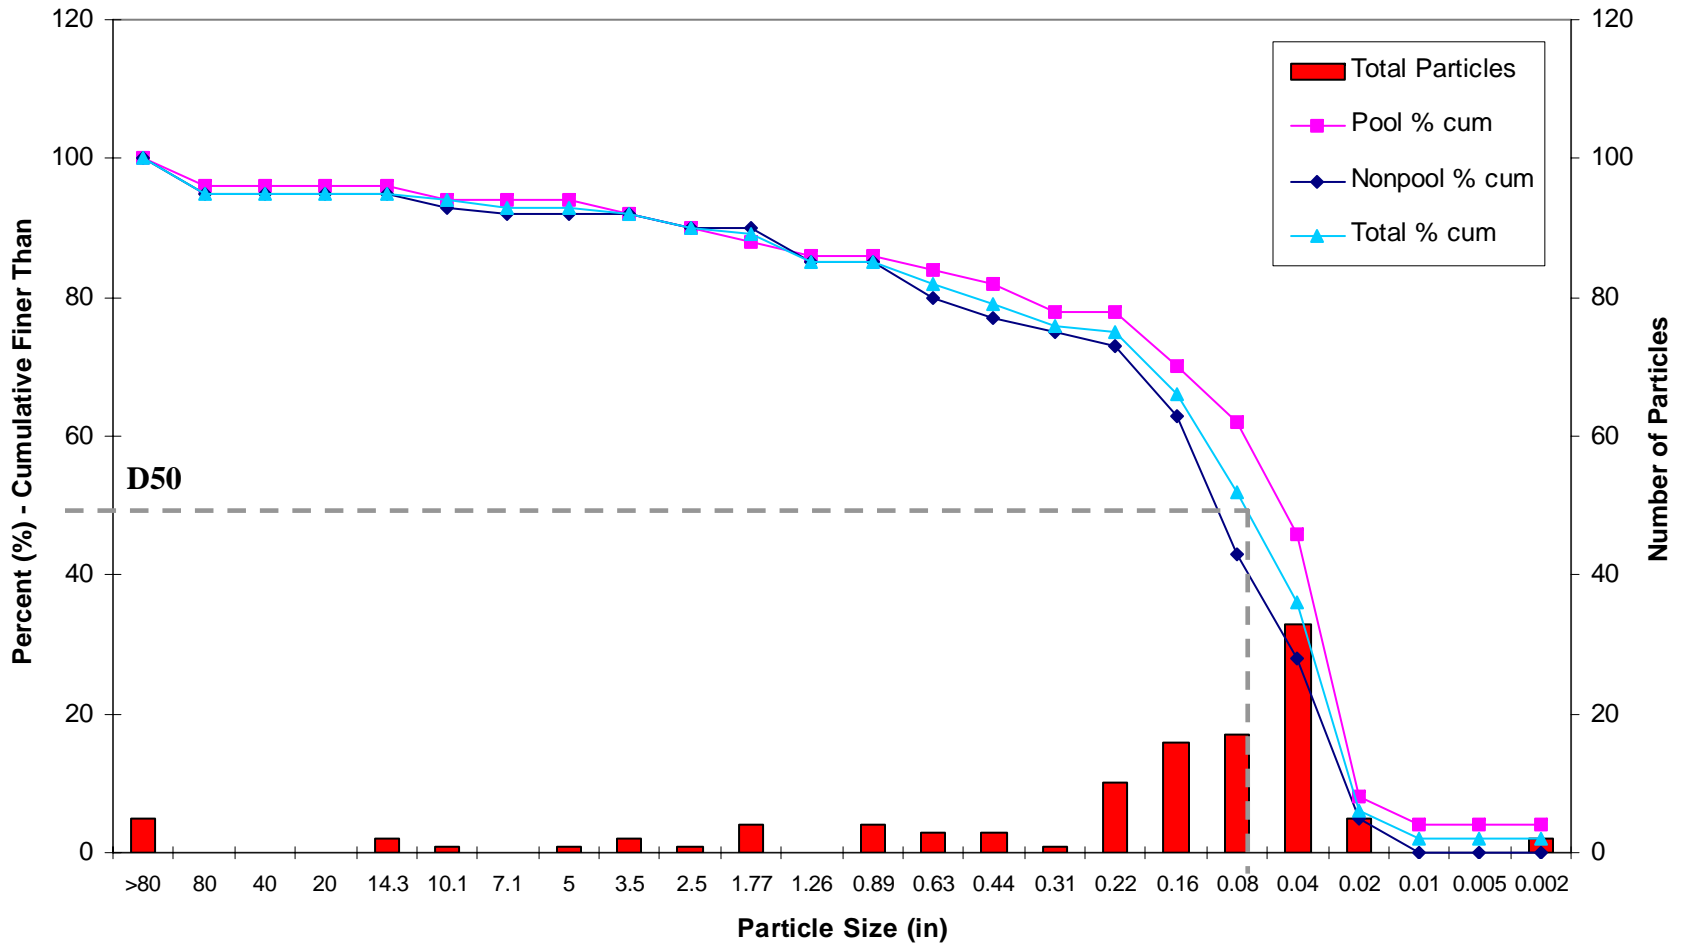
Figure 2-2. Manasquan River Pebble Count Data - Cumulative % versus Particle Size

Within the reach (~480 ft in length), approximately 30 percent was comprised of pools and 70 percent of the reach was comprised of non-pools (riffles, runs, and glides). Fifty-five percent of the pebble count stations were located at non-pools and forty-five percent of the pebble count stations were located in pools. Because only one small riffle (1 ft wide by 4 ft long) was observed within the reach, only one sample was collected within a riffle. Ten total samples were collected in runs/glides and pools to evenly sample all features. A total of 11 pebble count stations were recorded (Table 2-2). Because the width (wetted width) of the channel was approximately 30 ft wide, one sample was collected approximately every three feet moving perpendicular across the channel at the selected cross sections. The upper limit of each particle size class was graphed versus the cumulative percent finer than as shown in Figure 2-2. Based on this graph, the indexed D50 can be determined. The D50 is defined as 50 percent of the sampled population is equal to or finer than the representative particle diameter. This number determines the dominant particle size, which can be compared to or combined with the particle size of greatest observation. From Figure 2-2, the D50 is 0.07 inches, which is characterized as very coarse sand.
